OPERATIONAL TEST AND EVALUATION

CAMOUFLAGE AND CORROSION CONTROL (RF-101)

TAC-TR-63-8
October 1963

Operational Test and Evaluation
Camouflage and Corrosion Control (RF-101)

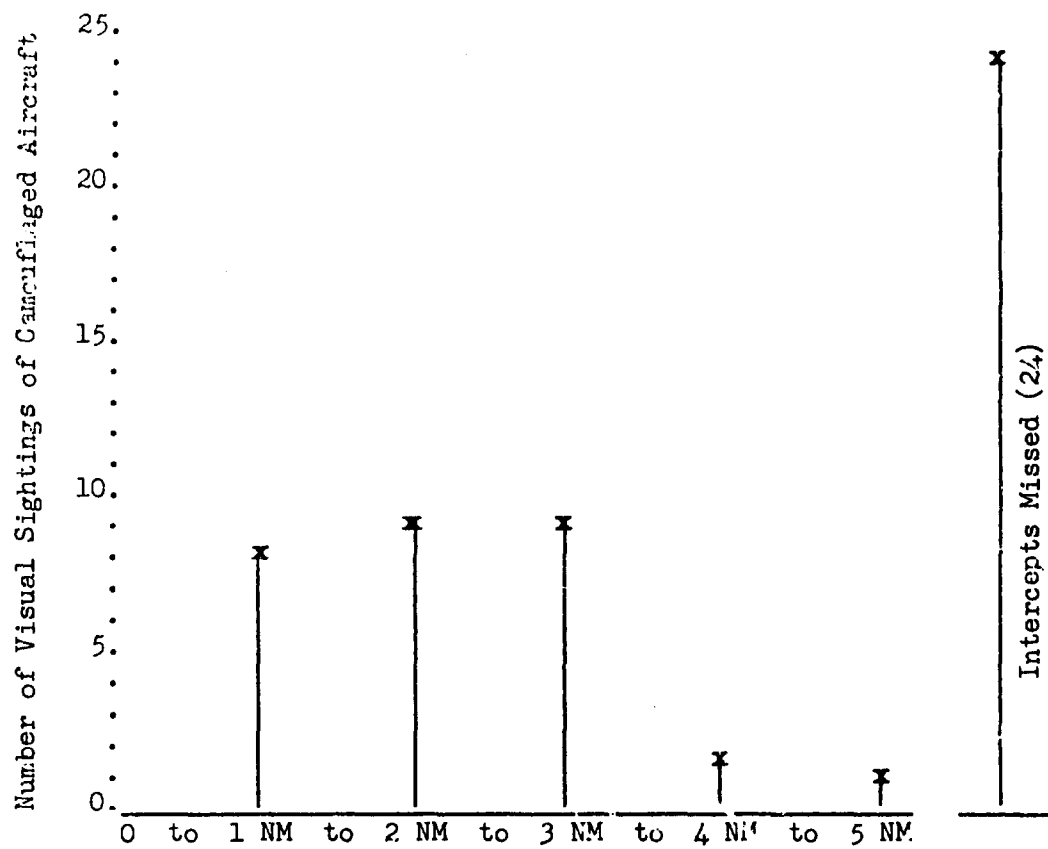
FIGURE 1. Results of Attempted Visual Interceptions of Camouflaged Aircraft (RF-101)

Total Intercepts Attempted - 54
 Total Effective Intercepts - 30
 Total Ineffective Intercepts - 24
 Percent Ineffective - 44.5%

c. Following are the results of the intercepts. Figure 1 shows the results of those intercepts in which only dull aircraft were targets; figure 2 is for those intercepts in which a bright aircraft was included as a target.

d. As shown by the graphic results, when sightings were effected the intercept distances of the dull and bright aircraft were approximately the same. However, that the dull aircraft was not seen on 44.5 percent of the attempted intercepts is considered to be the significant fact. This becomes more significant when compared to the bright target, which was missed on only 11.3 percent of the intercepts attempted. This degree of reduced detectability, attributed to the camouflage, was realized during interceptions on which the interceptor was constantly receiving azimuth and range information directly from the target aircraft pilot. This type of guidance is inherently more descriptive and timely than that which could be obtained from an intermediate source, such as a radar controller. In all cases, the interceptors were RF-101 aircraft and the intercept techniques were identical.

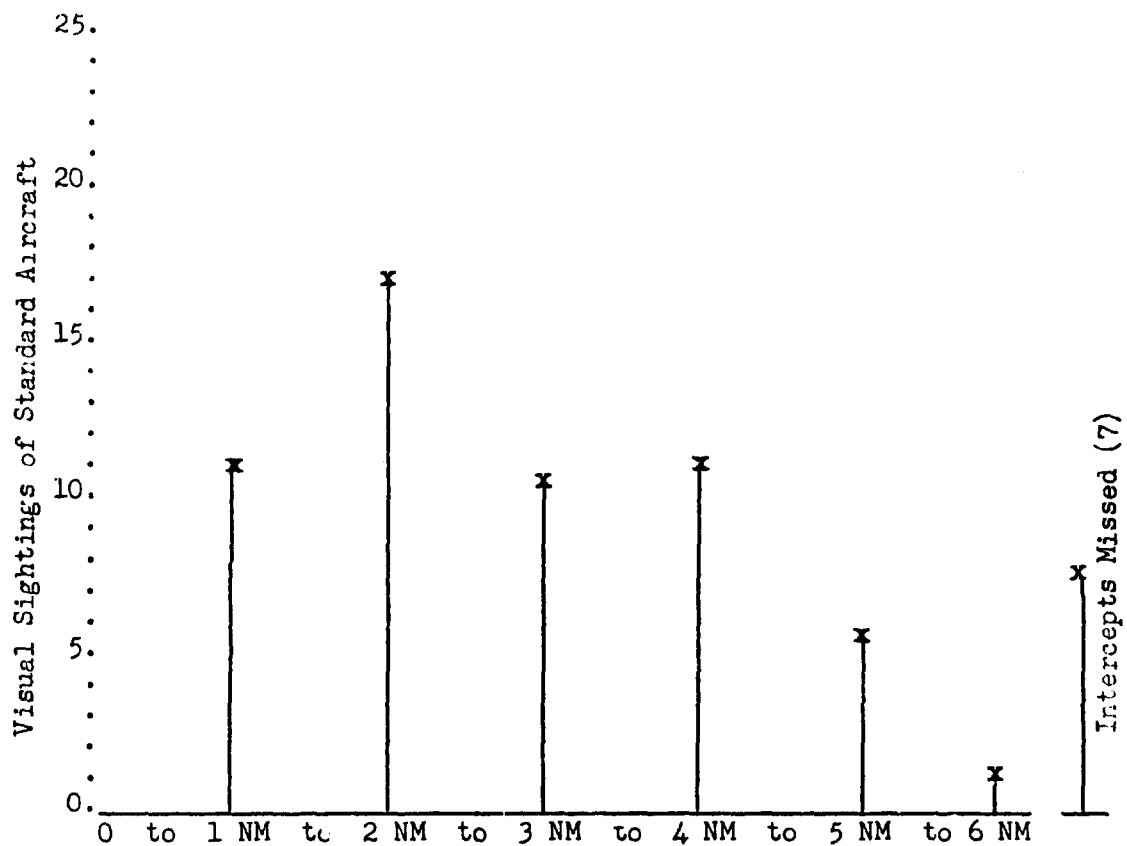
FIGURE 2. Results of Attempted Visual Interceptions of Standard Painted Aircraft (RF-101)

Total Number Interceptions Attempted-62
 Total Intercepts Effective - 55
 Total Intercepts Ineffective - 7
 Percentage of Ineffective Intercepts-
 11.3%
